DISCOVERING, THE HARD WAY, HOW A HIGH PERFORMANCE COUPLING INFLUENCED THE CRITICAL SPEEDS AND BEARING LOADING OF AN OVERHUNG RADIAL COMPRESSOR—A CASE HISTORY

ABSTRACT

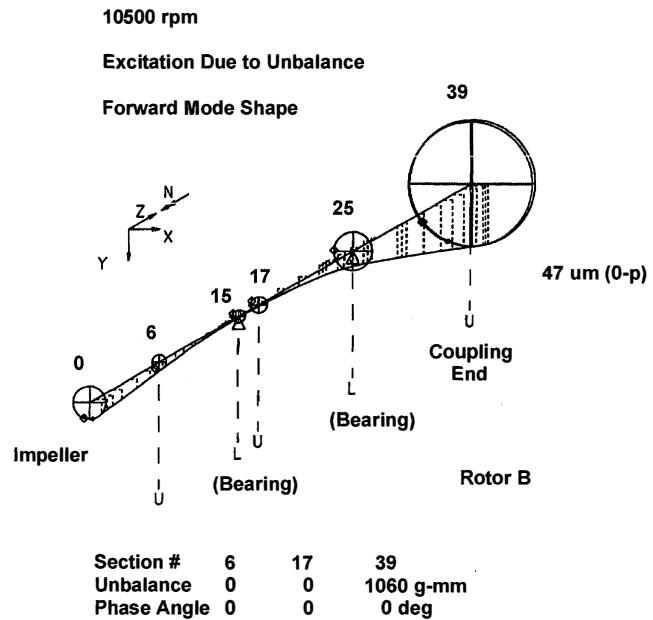
Figure 13. Unbalance Response Mode Shape for Model B.

But, even though the observed test resonance was very likely related to the new rotor (rotor B) model second critical, the rotor had been calculated to be critically damped, with an amplification factor of 1.2 (Table 1). Damped Eigen value stability analysis showed no problems. Log decrement values were well in the stable range. The high amplification was completely unexpected and more investigation was necessary.

through the resonance. The observed vibration magnitude was up to 250 μm with a corresponding phase shift. This result appeared to be only the initial onset of the resonance. The machine could be run up to 9300 rpm, with stable amplitudes at 40 μm to 60 μm with no phase shifting. But once the speed was increased above 9400 rpm, the amplitude would increase dramatically. Depicted in Figures 14, 15, and 16, are the nature and magnitude of the vibration.

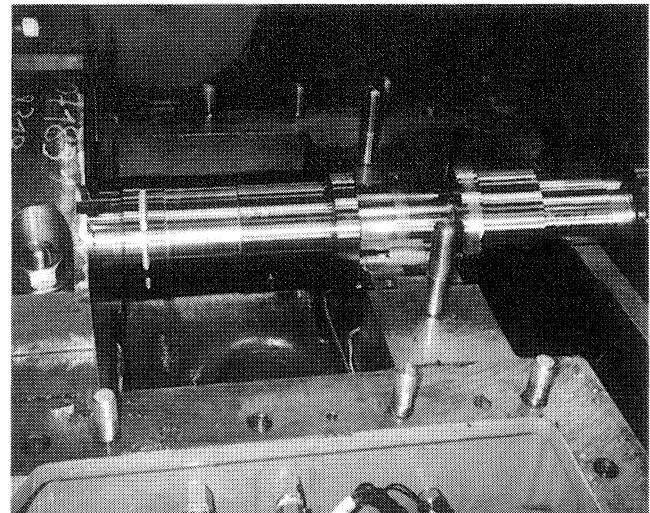
Figure 19. Bearing Pedestal.

- *Overhung bearing pedestal design*—A possible structural resonance was theorized within the overhung bearing pedestal design. The housing is a horizontally split design that allowed for impact testing of the unit in various stages of assembly and disassembly. However, the webs carrying the bearing systems are quite massive; therefore, the resultant Campbell diagrams showed no significant resonant frequencies. The fasteners mounting the bearing caps were eventually modified to provide a stiffer bearing assembly, but the effect was not quantifiable. This assembly is shown in Figure 19.

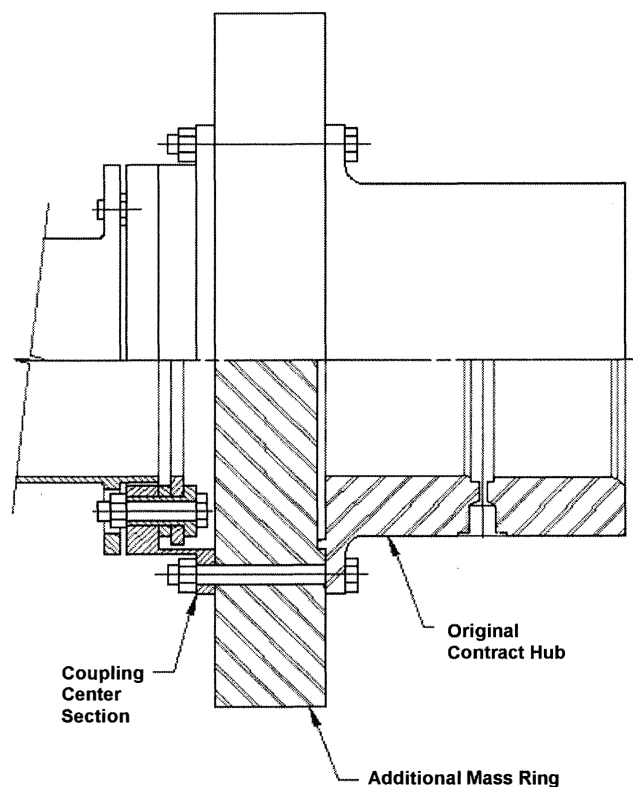
Figure 20. Original Test Coupling with First Trial Weight.

To check the original lateral model, a test was devised whereby an additional mass, a weight ring (Figure 20), was added to the contract coupling hub. Although the results (Figure 21) were promising, in that the resonant center frequency was decreased to 7000 rpm, the amplification factor was still too high (between 9 and 10). The ability to manufacture the ring to acceptable tolerances (for balance purposes) was cited as part of the reason for the high amplification factor. In other words, in order for a coupling/weight ring to run properly, tight tolerances on the locating diameters between the coupling hub and the trial weight were required, but were not achieved. It was at this point that thought was given to manufacturing a new half coupling that had the extra weight used in the original rotor lateral analysis.

It should also be noted here that there appears to be jump phenomena depicted on Figure 21, which indicates a highly nonlinear condition. However, it was assumed at the time, possibly incorrectly, that the odd vibration behavior was related to the unbalance in the weight ring assembly.

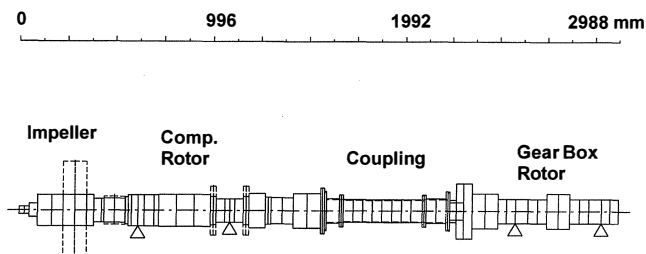
Figure 22. Test Train Model.

Normally, the rotor lateral analysis is modelled assuming the coupling can be divided into two distinct half sections, and that each rotor is isolated from the other by the coupling flexible elements. A more thorough test stand rotor analysis (with the compressor and the gearbox rotor) was done using the coupling flexible element bending moments and lateral stiffnesses (Figure 22), but no significant difference was calculated between the models.

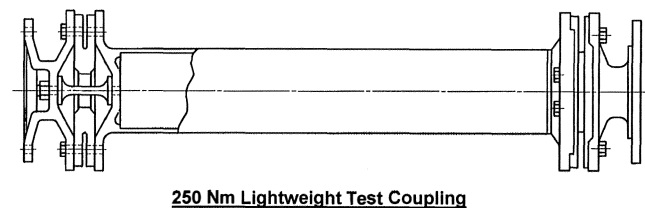
Figure 23. Shop Test Coupling.

- *Shop coupling test*—A different, shop test coupling (Figure 23) was balanced, then connected to the compressor rotor and spun. Again, the reasoning was that if the newer coupling worked and the contract one did not, there must likely be something wrong with the contract coupling.

The biggest distinction was the weight. The new test coupling weighed 2.7 kg and the contract coupling weighed 28 kg on the compressor end. In addition, the differences in flexible element bending, axial, and radial stiffnesses were significant. In other words, since there were all these dissimilarities that could affect the forces on, and therefore the vibration of, the end of the rotor shaft, the fact that the new coupling ran successfully could not prove that contract coupling was defective.

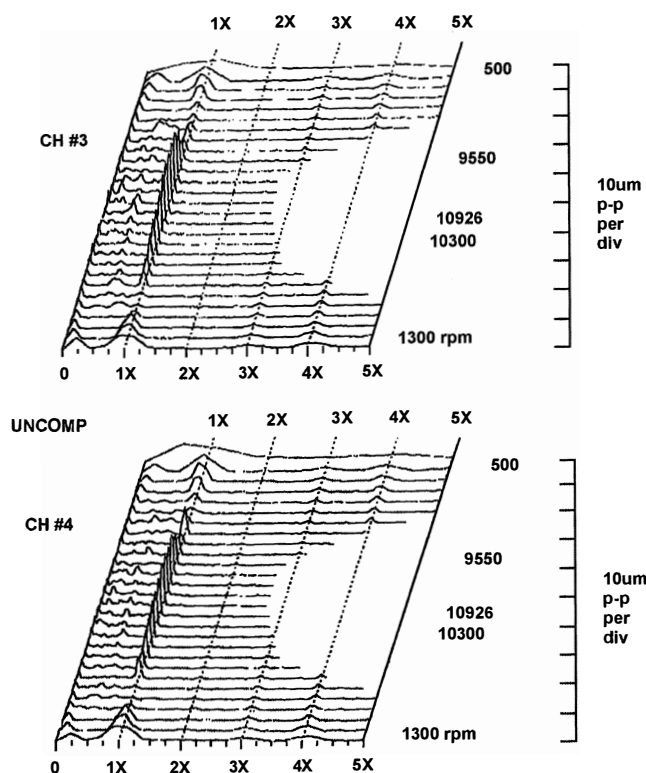
Figure 24. Shop Test Coupling Waterfall Diagram.

This arrangement was able to run successfully. The overall vibration was within API levels, there were no phase changing effects at speeds up to 10,900 rpm, and there was no significant amplification factor during shutdown (Figure 24). But, as before, there were questions about the validity of using these test results to deduce that the contract coupling was the problem. First of all, the couplings were completely different designs with different physical characteristics.

It can be seen here that the overhung mass of a coupling can have a significant effect on rotor critical speeds, as noted by Wolford [5]. The effect of the reduced overhung test mass was not only to raise the second critical speed, but also to raise the ratio of the second to first critical, as predicted by Weaver [6].

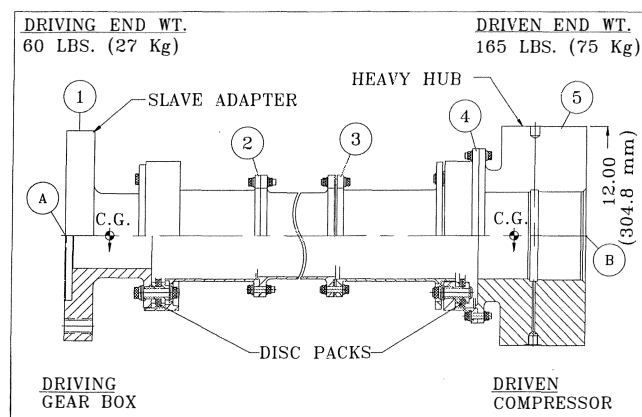
Figure 28. Final Test Coupling with Contract Heavy Hub with Indication Points.

There were a few things done to ensure that the coupling operated well balance-wise. The main focus of these other efforts was on installation. Specific instructions were given to the test floor to turnover the coupled rotors before the test and check the runouts of key diameters on the installed coupling (Figure 28) to ensure that they were within the values of Table 3.

This was an important inspection, just as important as the coupling balancing operation. For example, if it were determined from indicator readings that the hub body (measurement 5 in Figure 28) ran out 0.002 in (51 μ m) TIR to the center of shaft rotation, that would mean that the coupling’s axis of rotation was shifted 0.001 in (0.002/2) from the center of shaft rotation. This is equivalent to 1000 micro-in (25,400 μ m), which would be 20 times the API 671 [3] assembly balance tolerance of 4W/N (50 μ m). This topic is covered in the literature [4].

The final test series at full operating speed included the new “heavy” 75 kg half coupling mated to the rest of the test stand coupling (Figure 28), and significant bearing modifications.
